KITCHELL LAKE DAM

NJ 00026

PHASE 1 INSPECTION REPORT NATIONAL DAM SAFETY PROGRAM

FEBRUARY 1980

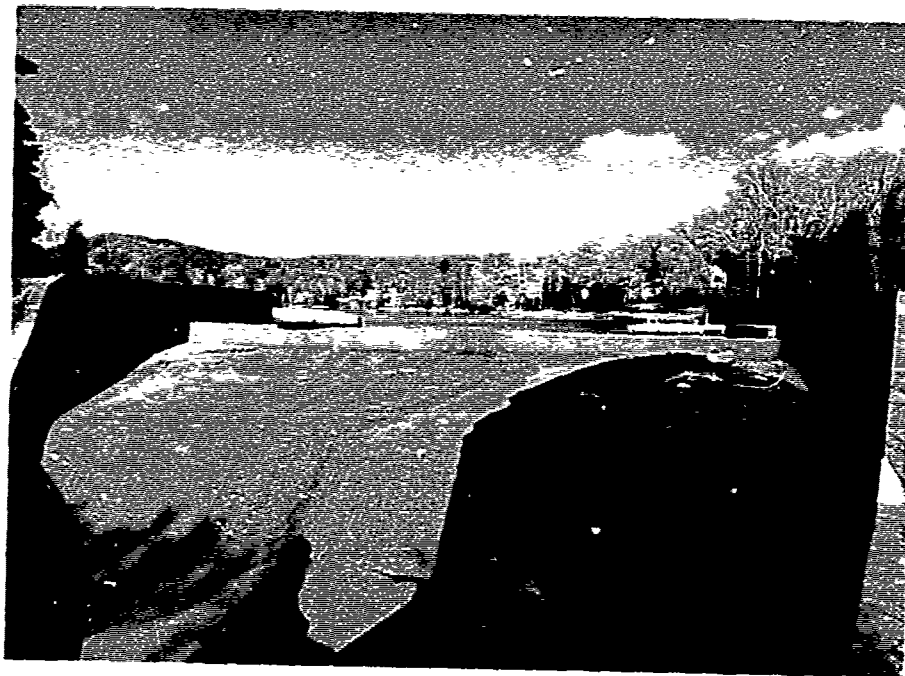
Photo 11 - View of spillway looking upstream. Note low level outlet drains in apron at bottom left and at right center. Also note completed repairs to right abutment mentioned in Photo 2. (Photo taken on January 21, 1980)
